# ConocoPhillips Mississippi River Pipeline Release

August 6 - October 3, 2003

presented by Tim Ganz, former State On-Scene Coordinator,  
Missouri Department of Natural Resources  
Environmental Emergency Response Section

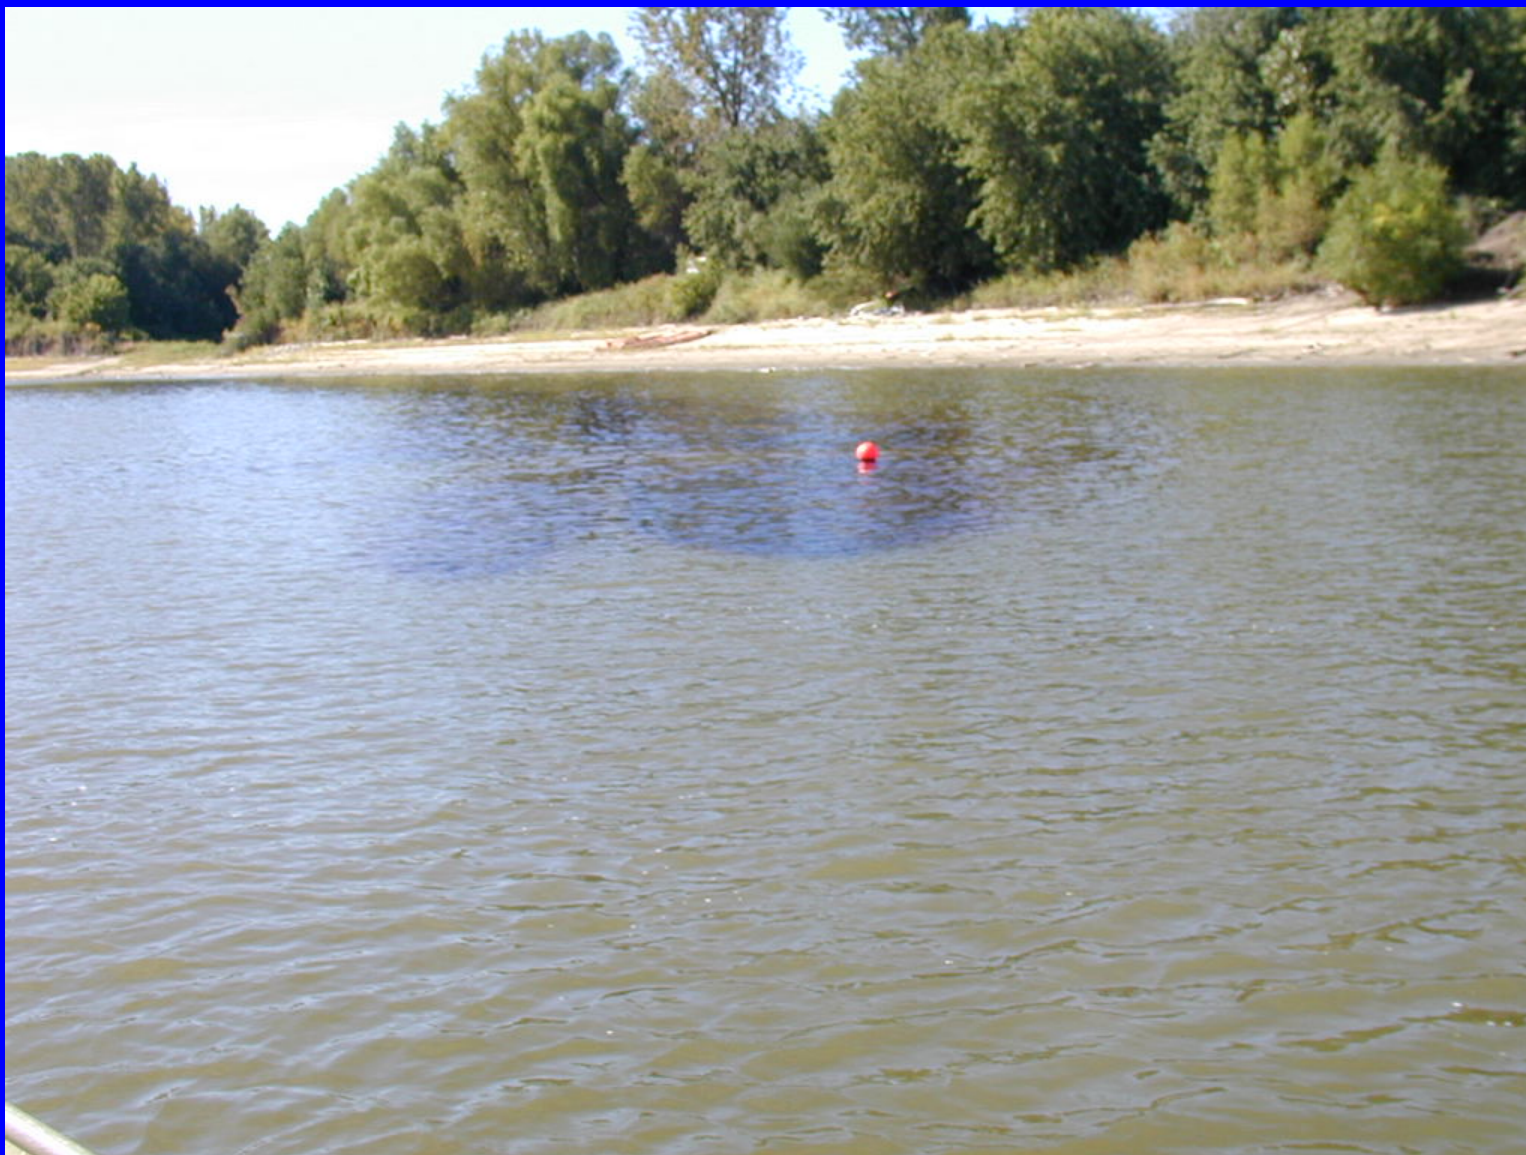
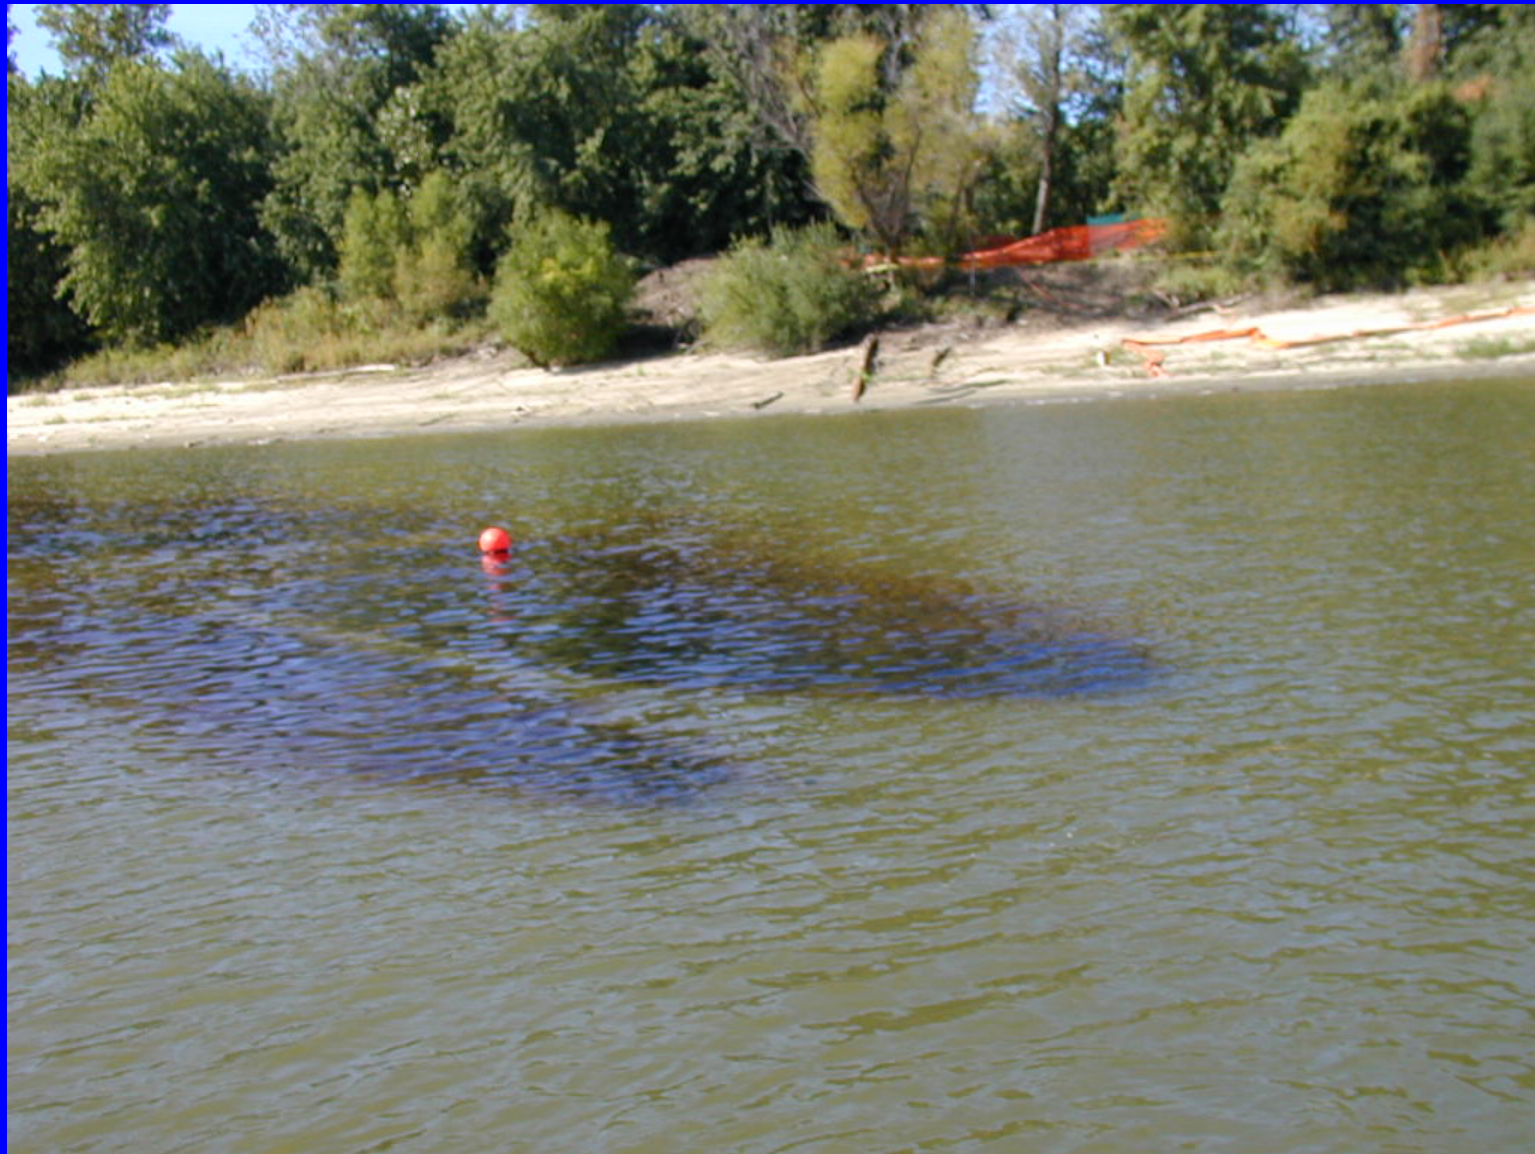
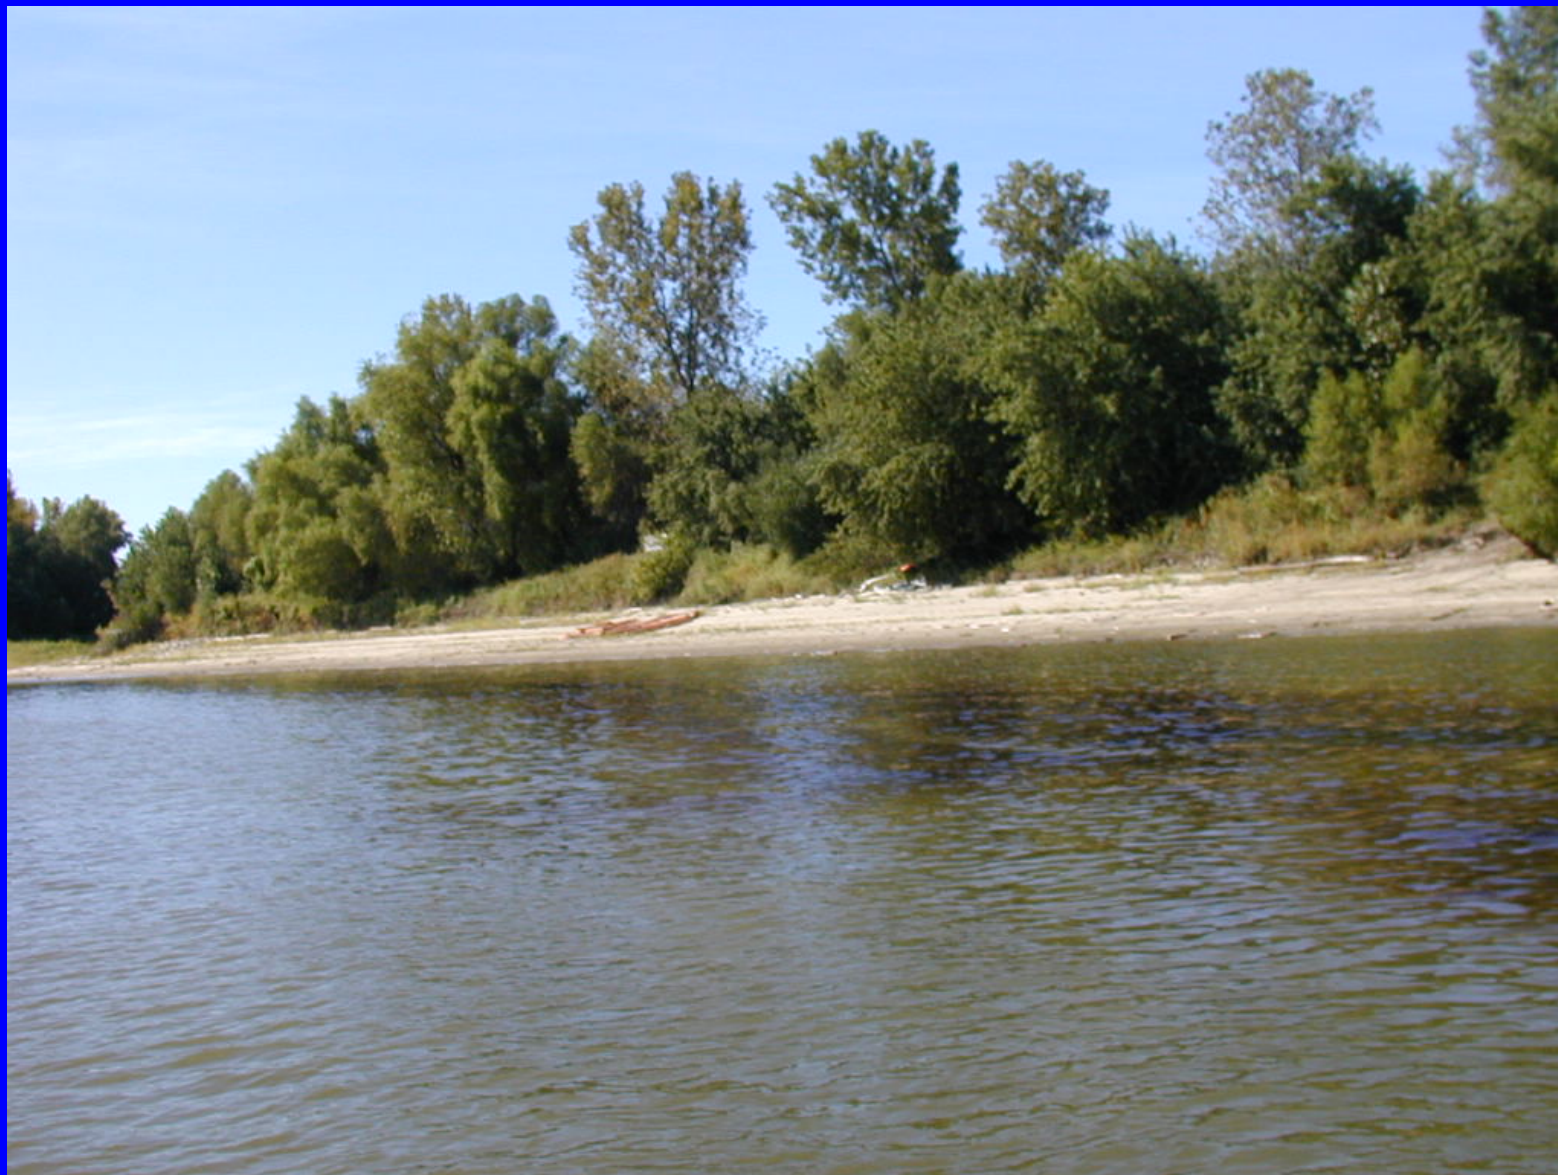
- By September 19, 2003, the south line was ready to be filled with cement/grout
- On September 25, 2003, a cement mixture was introduced into the Illinois side of the south line using a horizontal drill rig and pumps
- Approximately 2,100' of line was filled when a slug of crude oil was noticed in the in the water near the site of the original leak
- The oil was apparently pushed out of hole in the line due to displacement by the concrete mixture

## Secondary release of crude oil - 09/25/03

- Oil slick approximately 300 yards in length and 20' in width
- Containment measures took approximately one hour to put in place
- Due to prevailing wind and current conditions the majority of the oil washed up on the Missouri shoreline just downstream from the leak site

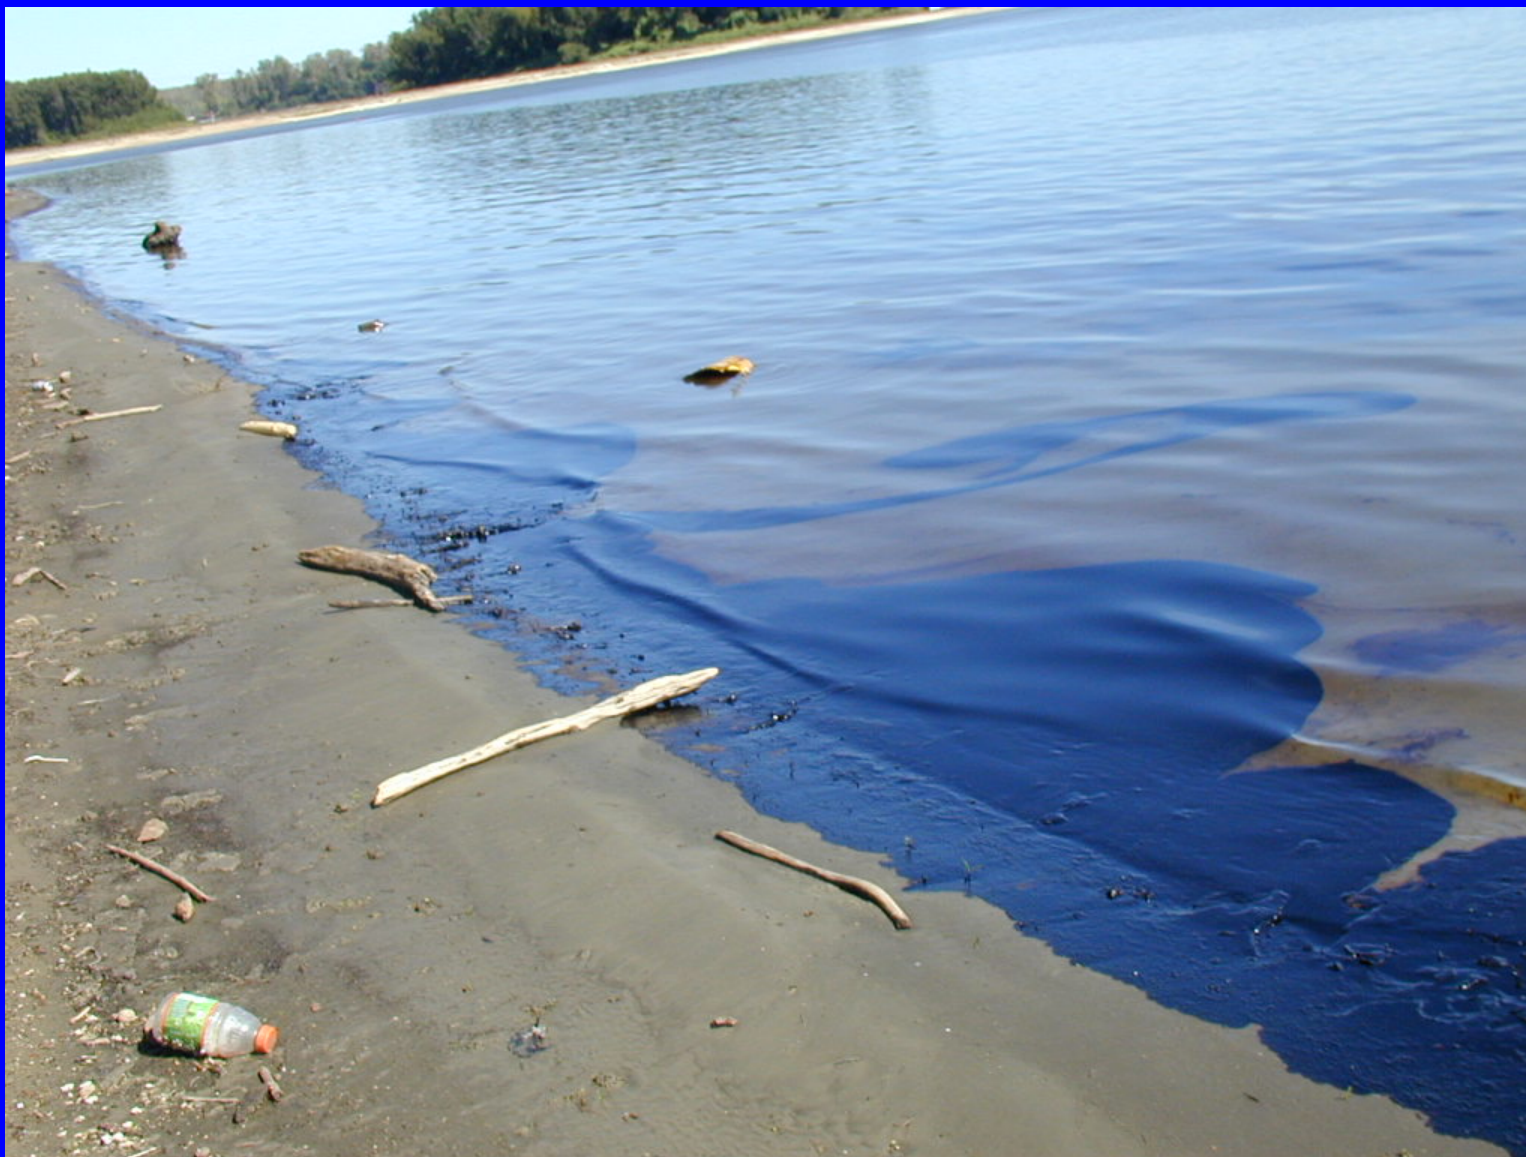
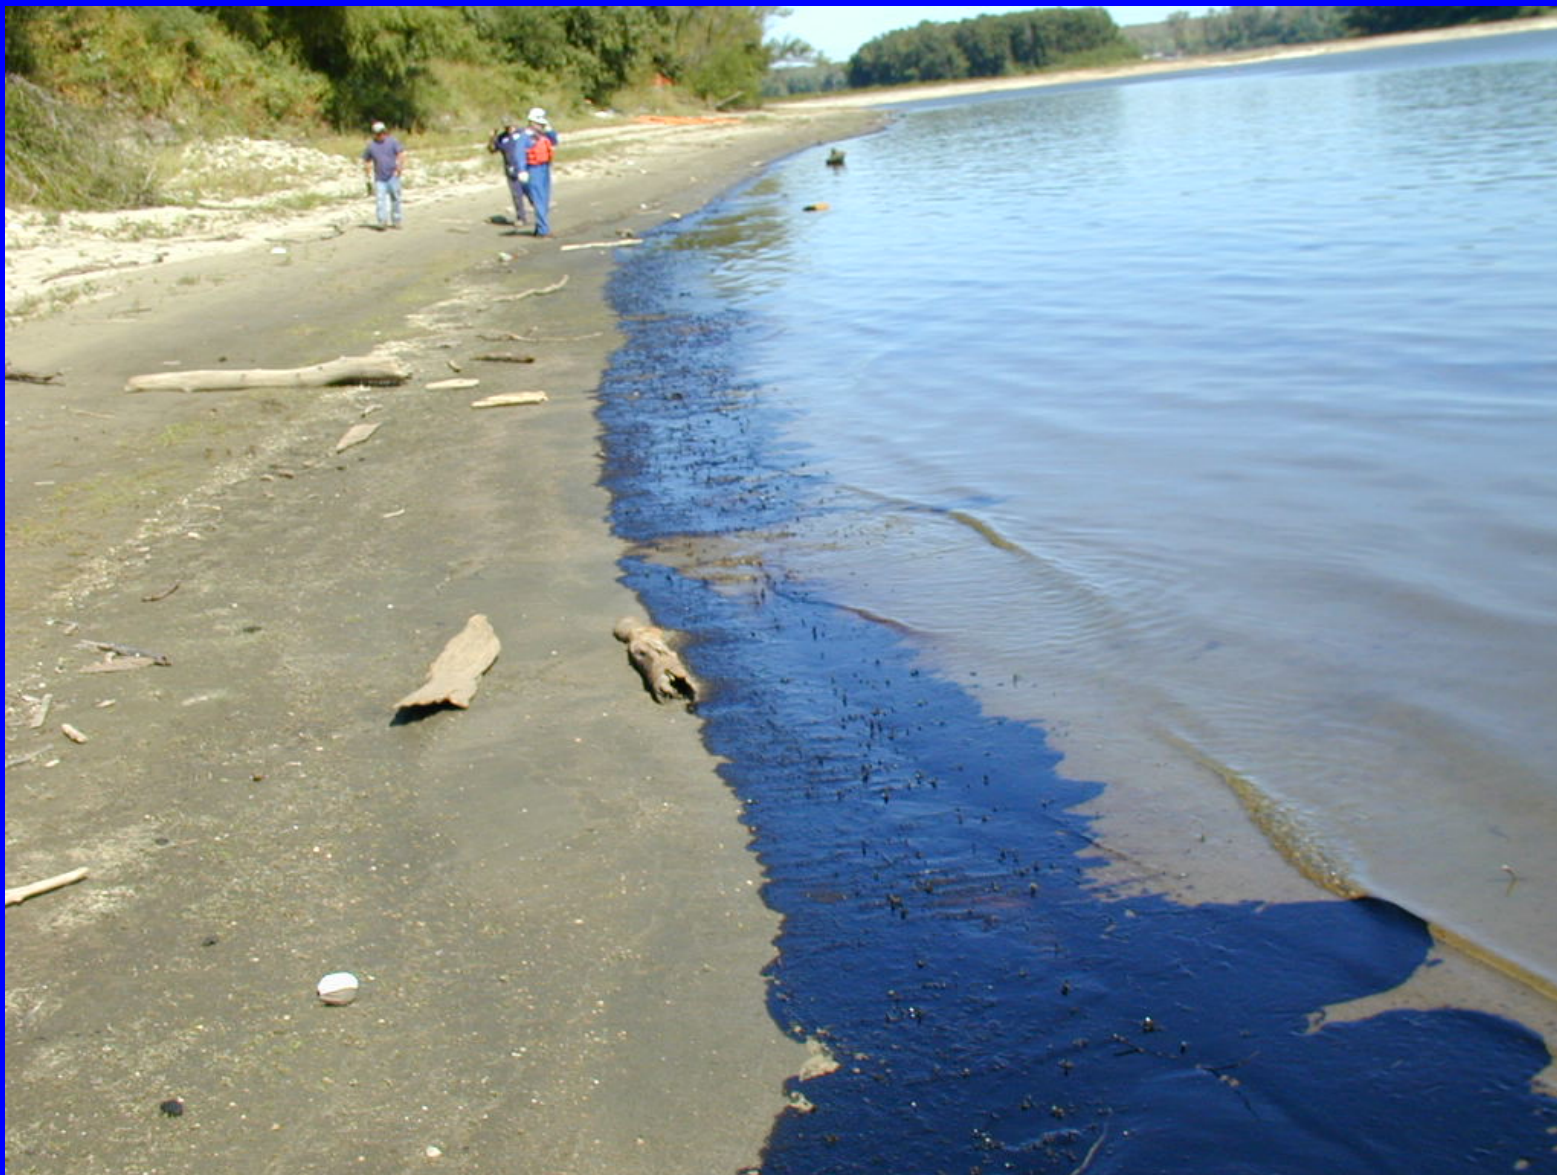
## Crude oil on beach - 09/25/03

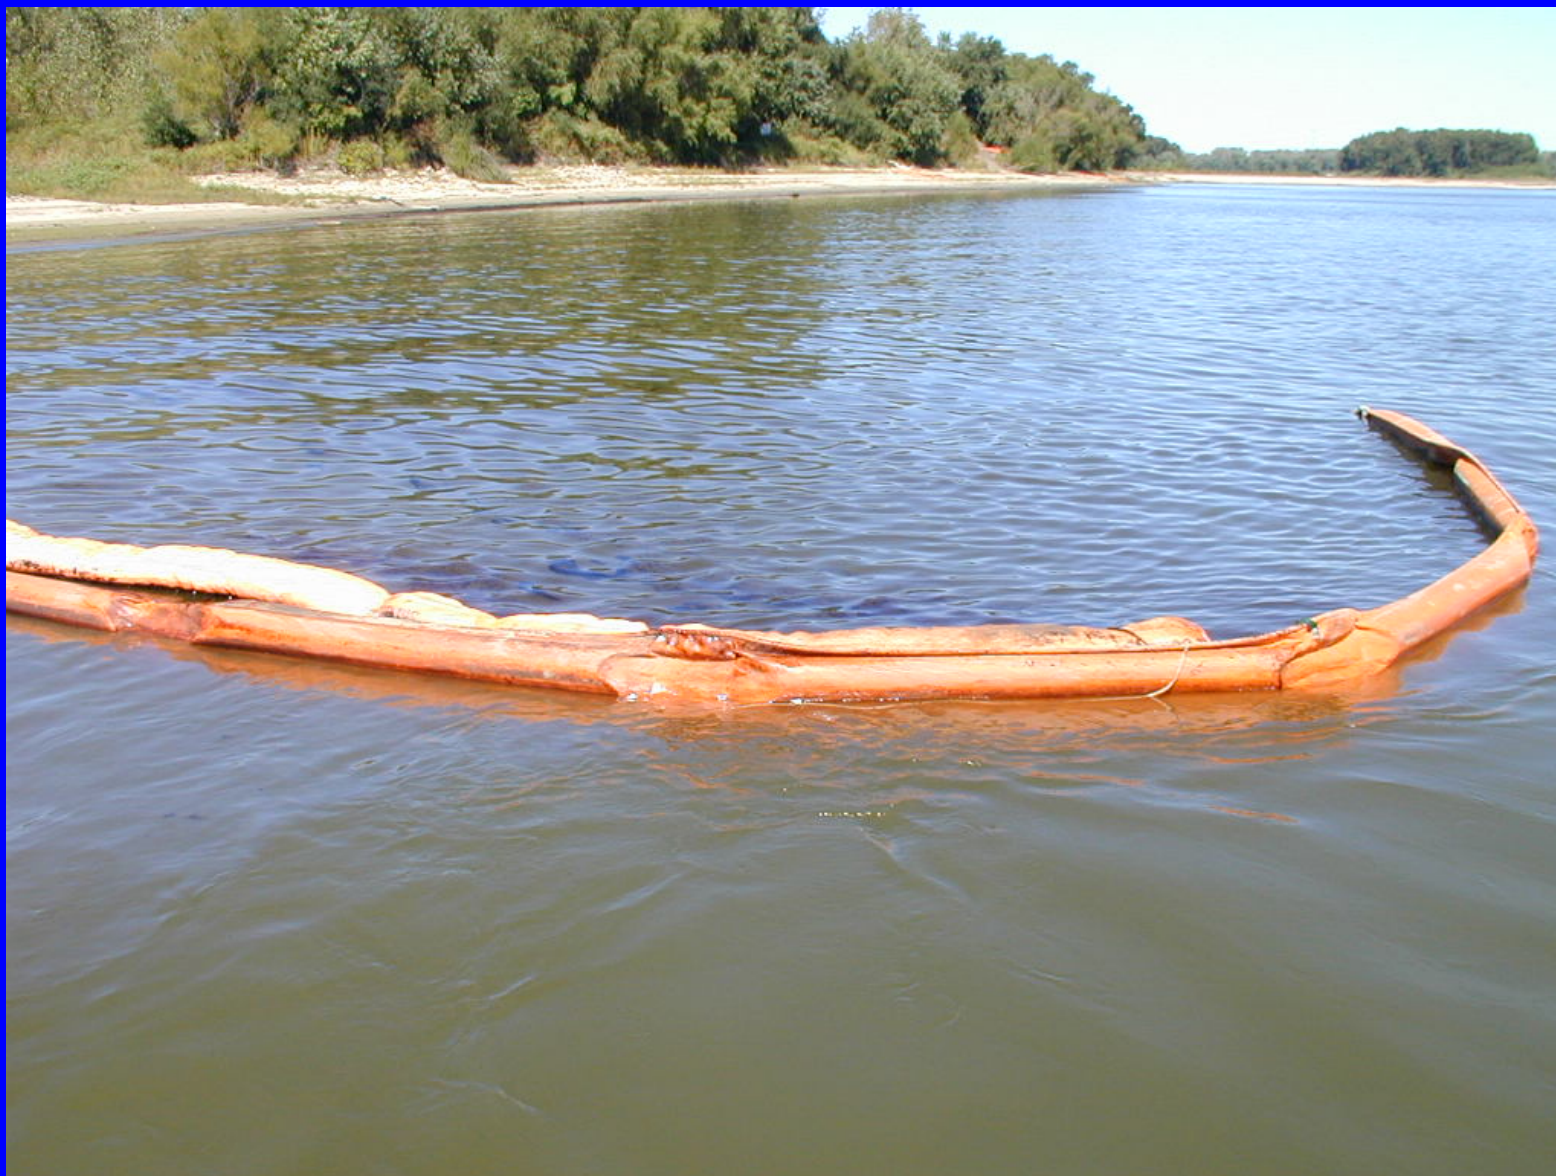
## Initial containment boom - 09/25/03

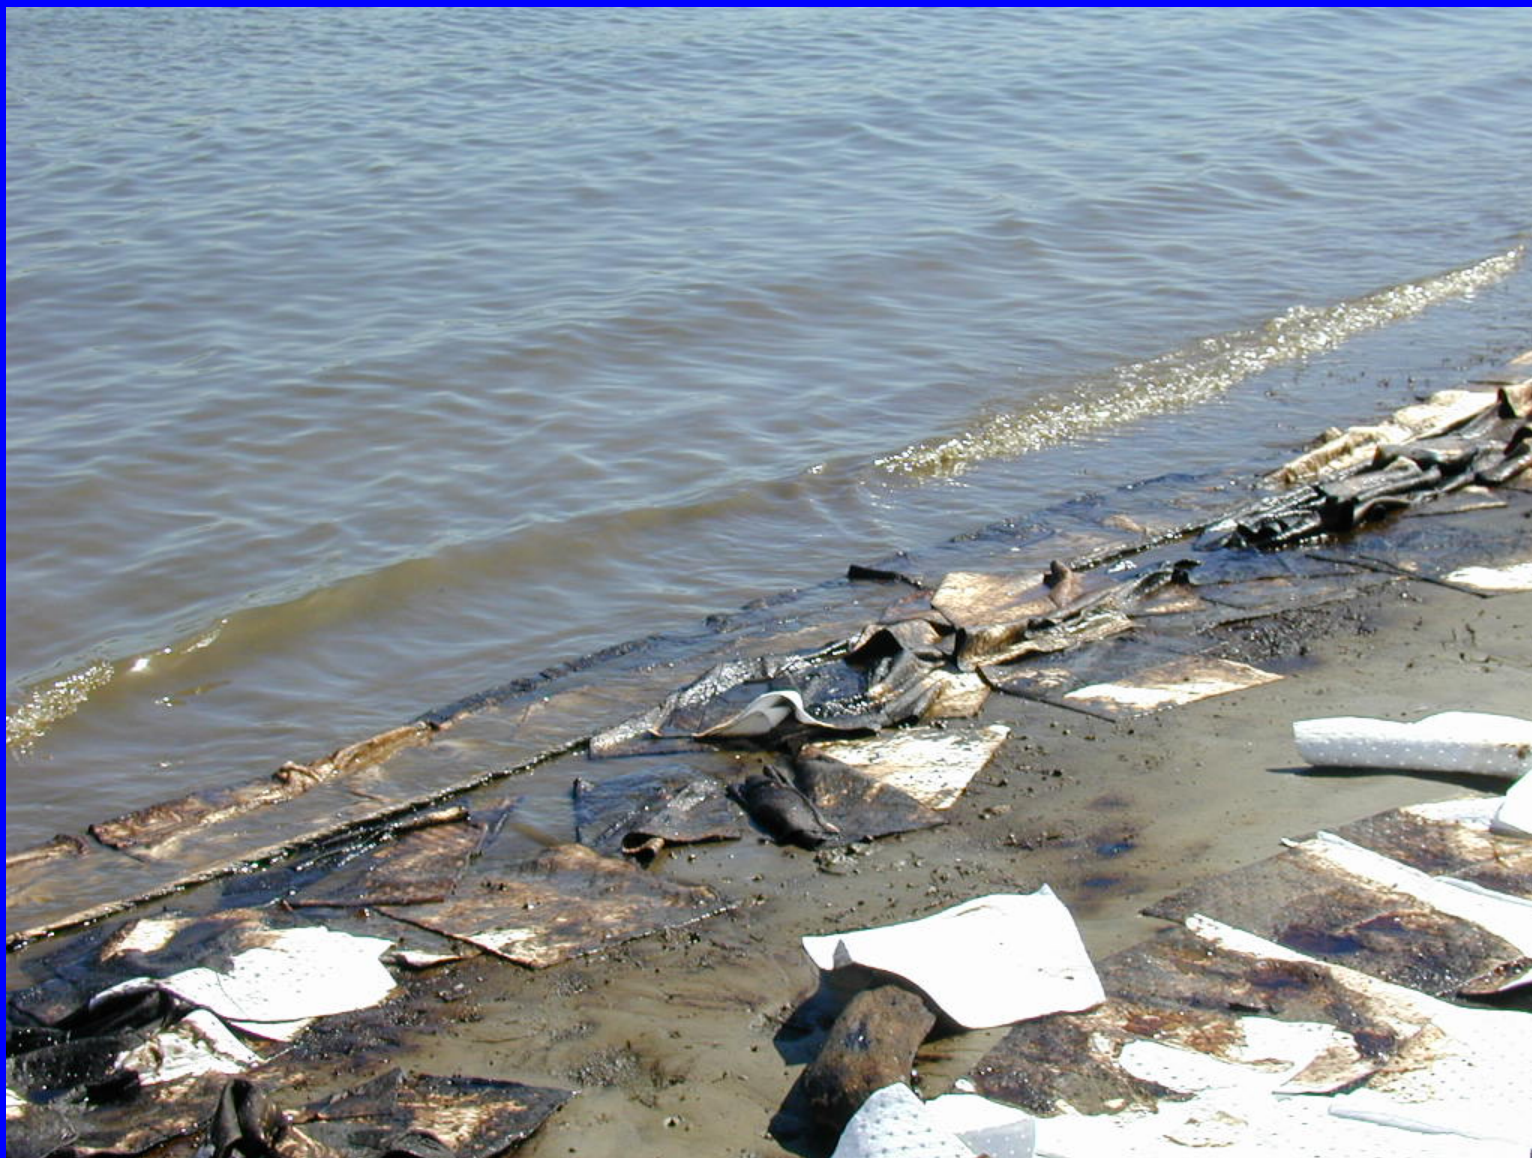
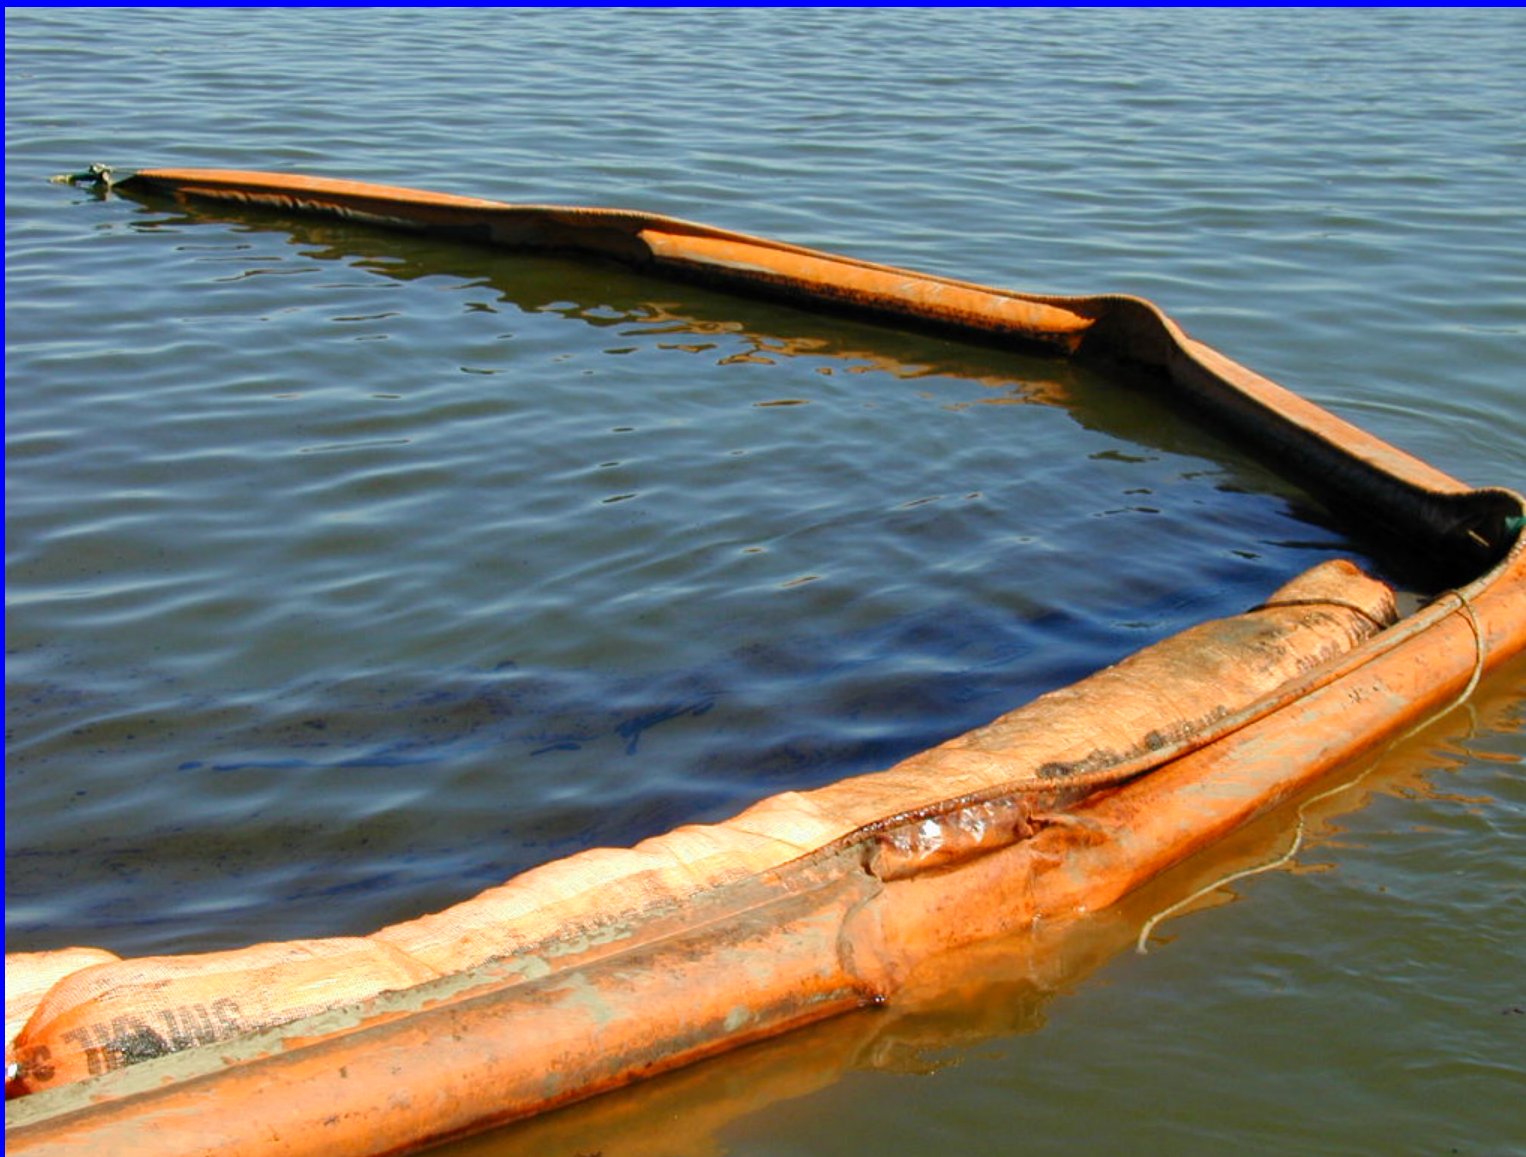
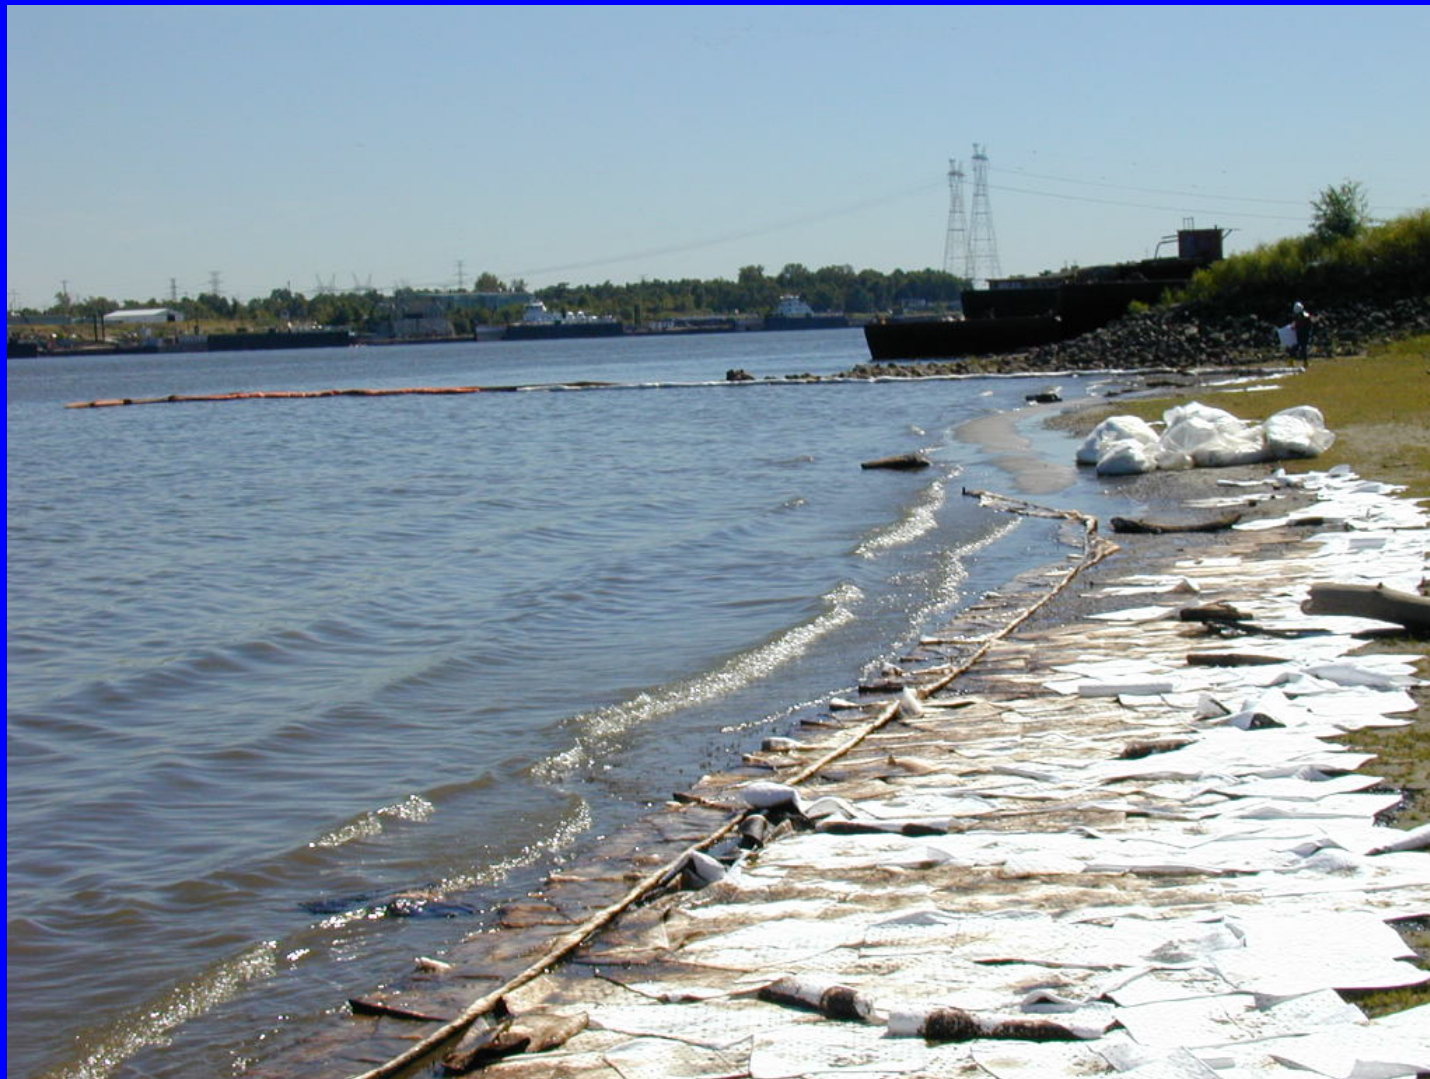
## Initial clean up of crude oil - 09/25/03

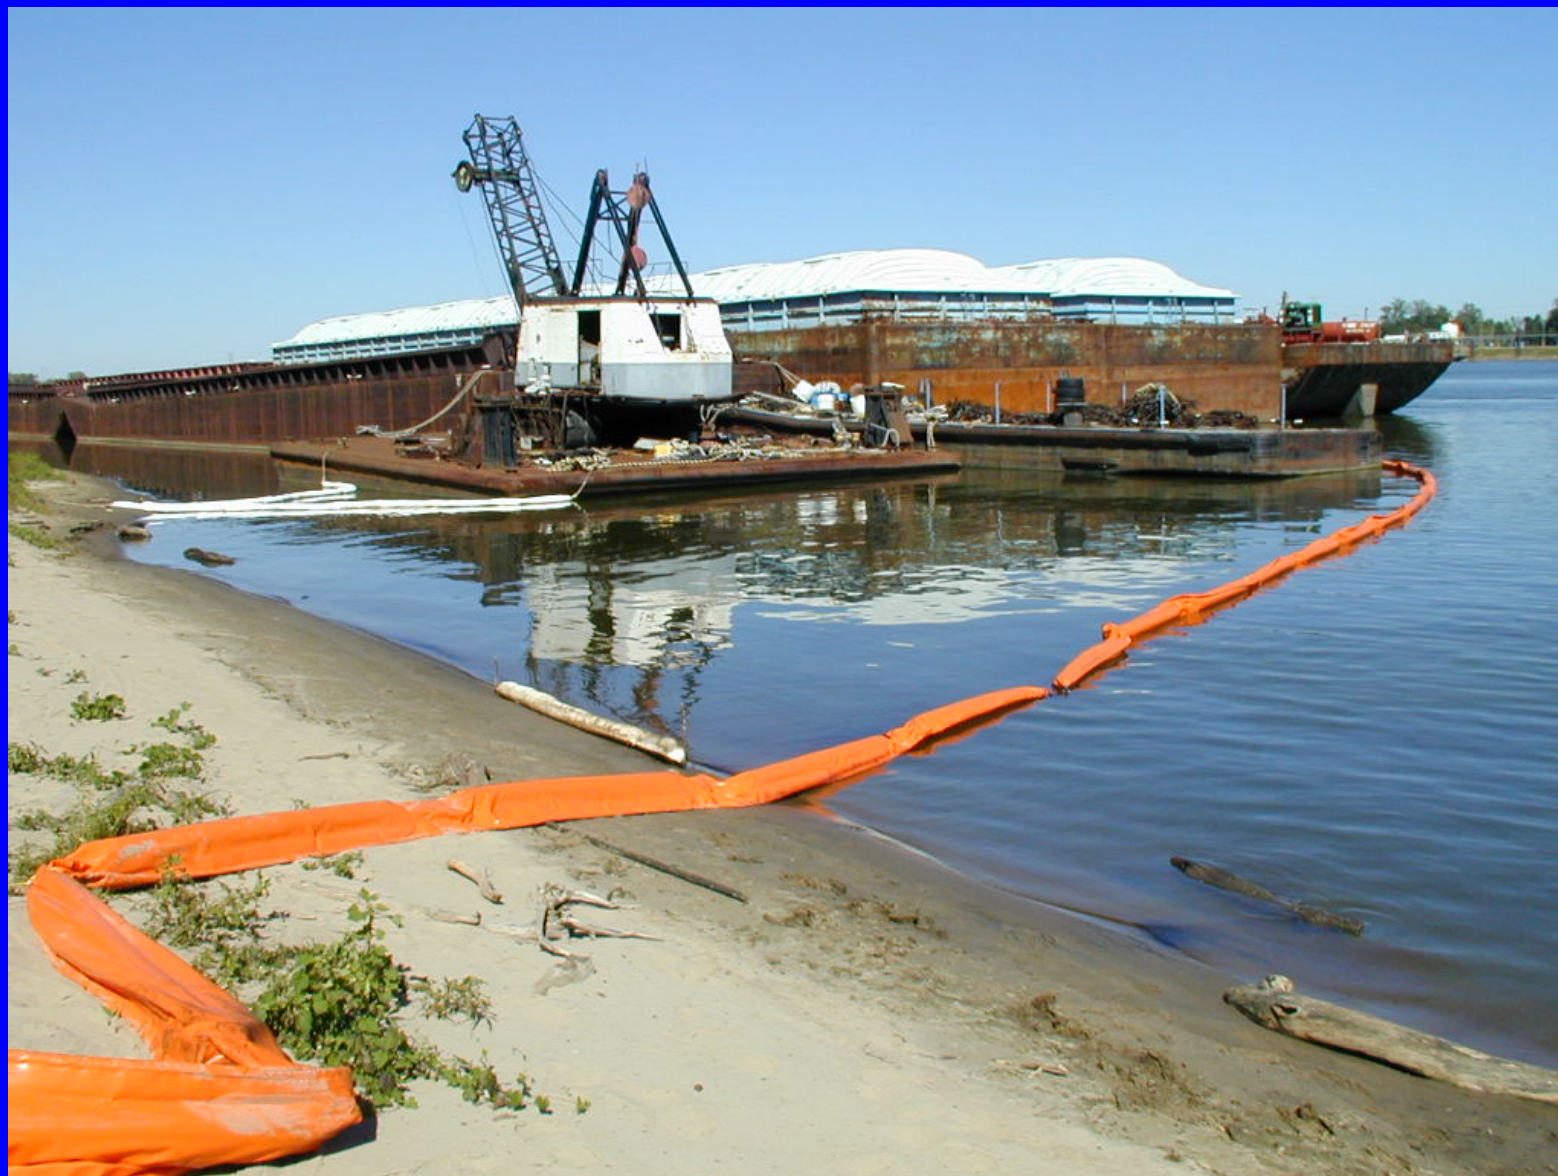
Containment boom deployed around barges - 09/25/03

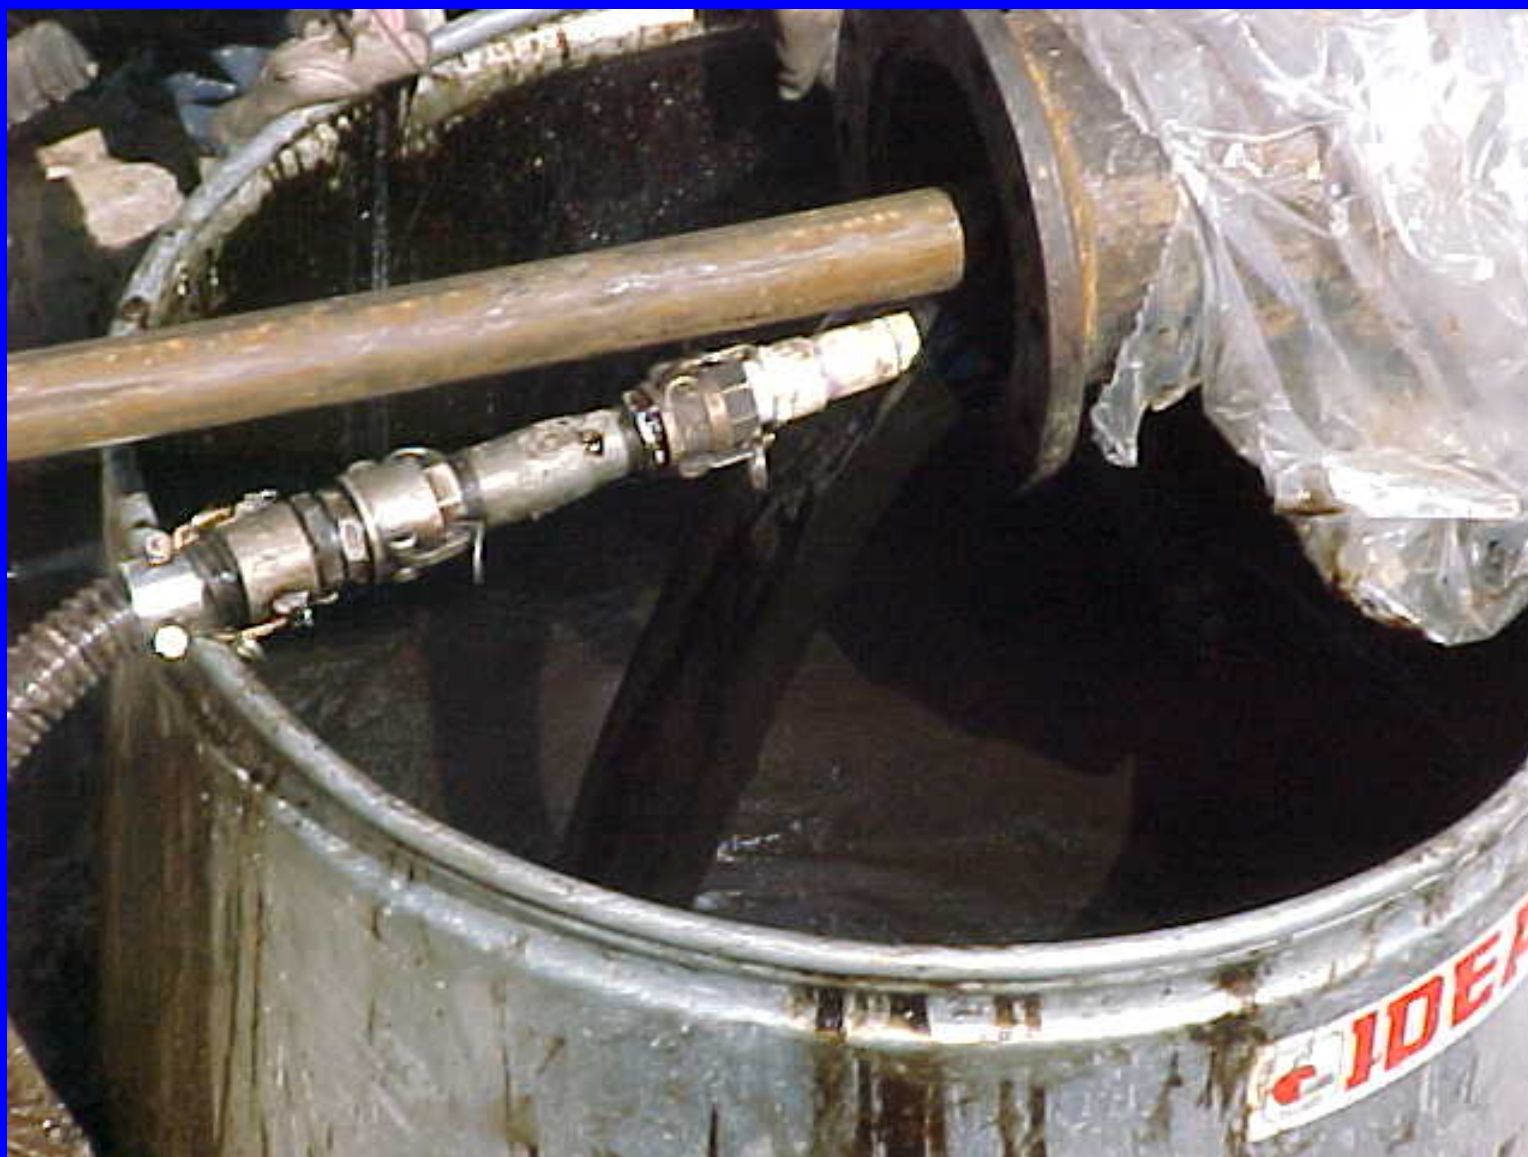
Oil discharging from south pipeline - 09/29/03

- Drilling mud was pumped into the Missouri side of the south line to complete the filling of the line
- An additional 5 barrels of crude were recovered from this process
- Line permanently capped – abandonment complete
- Same process utilized on the north line

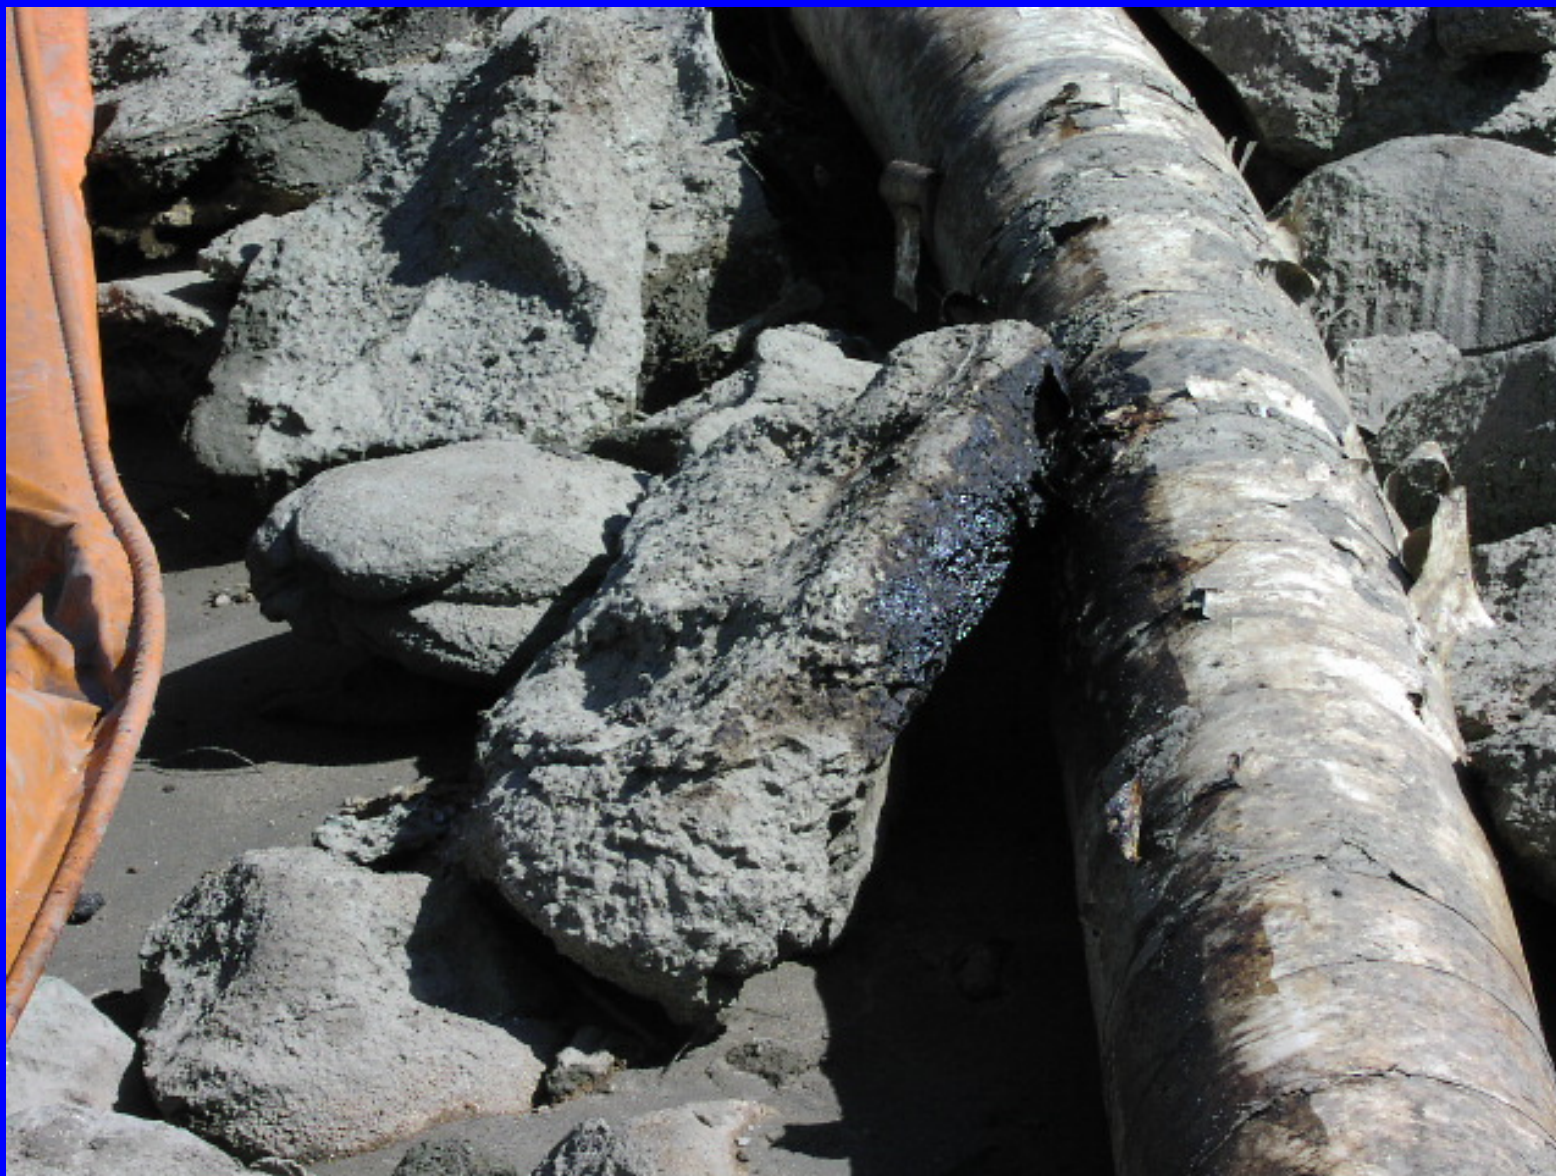
## Oil staining on rocks - 09/29/03
